EFFECTS OF HARD WATER ON CIRCUITSOLVER[®]

ONGOING TEST RESULTS OF CIRCUITSOLVER[®] IN HARD WATER SITUATIONS

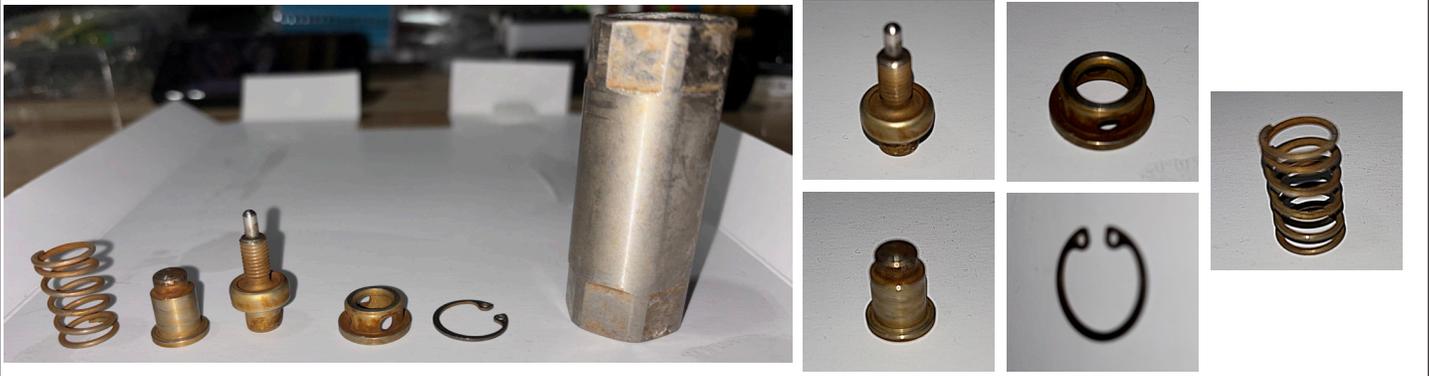
CircuitSolver[®] from the in-house test after over 12 years of installation. Unit disassembled and photographed.

There was no visible signs of mineral deposits, wear, or fatigue in the installation. CircuitSolver[®] is cycling normally after approximately 231,040 modulations. After disassembly and inspection, parts were not cleaned but simply reassembled and the CircuitSolver[®] was put back into service. There will be more follow up inspections and reports as these test installations continue to run. In addition to the tests presented, we will be incorporating data from other, older installations as it is received.
